Restoration of hammer foundations in forging industry — a case study

G. D. Shanbag, P. G. Gokhale
and B. V. Bhedasgaonkar

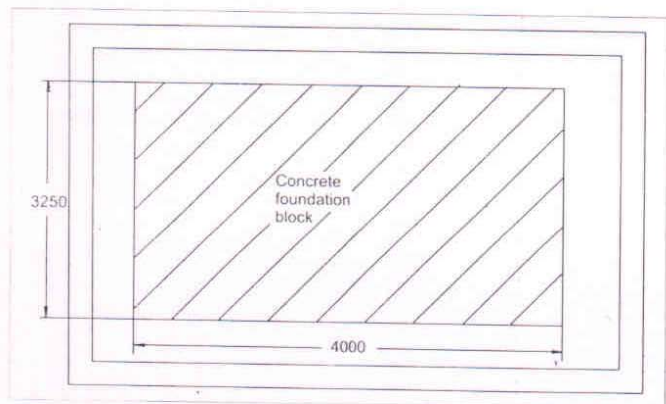
Fig 1 Plan of 1500-kg hammer foundation

Of the three foundations, two foundations, namely, the 500-kg and 1500-kg hammer foundations developed a tilt. This resulted in increased thickness of forging jobs on one side, consequently adding to rejection. Figs 1 and 2 show the plan and section of a foundation with the tilt. The settlement in 500-kg hammer foundation was uniform and about 100 mm. That in the case of the 1500-kg hammer was 50 to 150 mm tilting towards one side.

In case of 1500-kg hammer, the problem of tilt was first noticed nearly two and half years after putting the foundation to use. Thereafter for six months the tilt went on increasing. The lubricant used as flux for first two and half years was LD oil. The detection of problem coincided with the time of changing from LD oil to a special flux supplied by a manufacturer, which was environment and human friendly, as claimed.

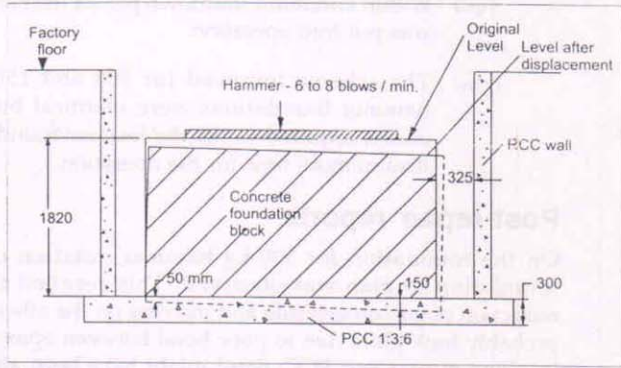
Fig 2 Section through 1500-kg hammer foundation

Low quality concrete, probably poorly-cured, was sandwiched between the hard rock strata below and the foundation mass with a continuous hammer load and impact. The oil used in the earlier years may also have affected the interfacial bond between aggregates and cement paste and weakened it.
