Repair of RC structures in cement plants - A case study

B. V. Bhedasgaonkar

A number of reinforced concrete structures in some cement plants were investigated and repaired using modern techniques. Appropriate repair method was used for rectifying the damage. Polymeric materials and systems used in repair enabled quick repairs to be carried out without major shut-down. The paper presents case studies of repairs to reinforced concrete structures in three different cement plants.

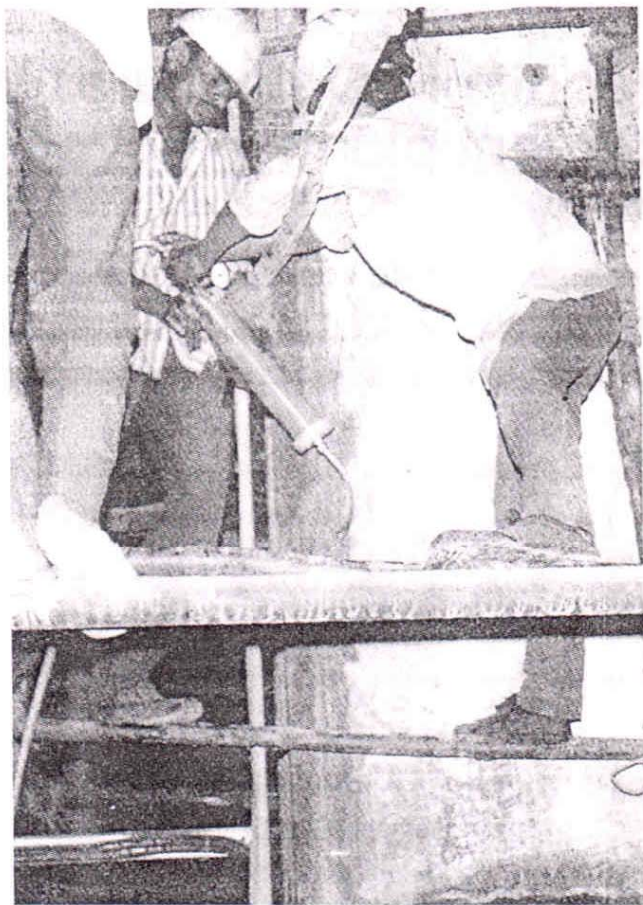
Due to excessive vibrations which are transmitted to the main column foundation of lime stone crusher, a crack of approximately 5-mm width had developed throughout the periphery of column. This was at the level of construction joint between columns and beam haunches. The size of the column was 1.2 m x 2.4 m approximately, Fig 1.

Fig 1 Strengthening of the column using epoxy resin

After cleaning and widening of the cracked portion, mild steel nozzles of 12 mm diameter were placed with epoxy putty at 300 mm on centres all along the periphery. After 24 hours injection grouting was done with a low-viscosity, high molecular weight thermoset polymer grout with a pressure of 4 kg/cm². Honey combs and even hairline cracks could be filled upto full depth of concrete as viscosity of grout used was

very low. It also helped in strengthening parent concrete of column foundation. The polymer also filled the gap between concrete and vertical reinforcement. This gap was created due to vibration from continued use of the crusher in spite of the distress.

Subsequently injection grouting was carried out once again with low viscosity epoxy resin system with a pressure of 6-8 kg/cm². By virtue of its low viscosity it could penetrate into cracks present in the concrete. As this system is non-shrinking and has good bond with concrete, the original strength of concrete could be restored.

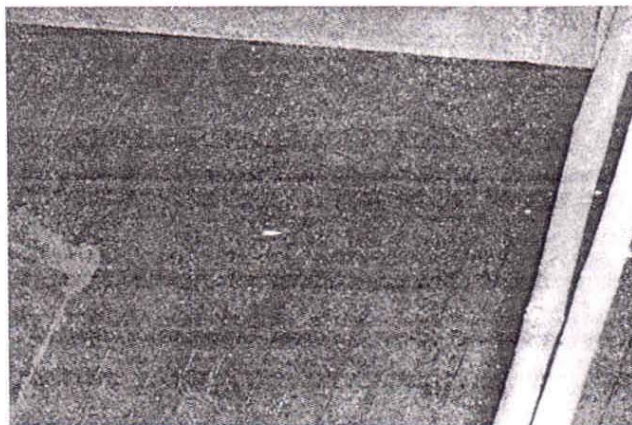
Fig 2 Repair of slag drier slab using anti-corrosive system

Due to excessive heat slag drier slab was getting damaged. In view of the critical nature of the unit, it was difficult to get a long shutdown. To repair this slab, shutdown was essential. So repair schedule was prepared in such a way that the work could be completed in just 3 days.

On the first day, scaffolding of about 15 m² area was completed in one hour. Subsequent activities such as chipping, bar cleaning, anti-corrosive coating of bars were carried out on the same day, Fig 2.

Next day, application of bond coat and polymer-modified mortar in layer-by-layer was carried out. Since the depth of repair is 40 mm the activity involving application of polymer-modified mortar took two days. A quick-setting mortar was developed for this purpose.

The plant was operational from the fourth day. However, the scaffolding top was covered by AC sheet so that newly applied mortar was not exposed to direct heat: Polymer-modified mortar was cured with water for two days.

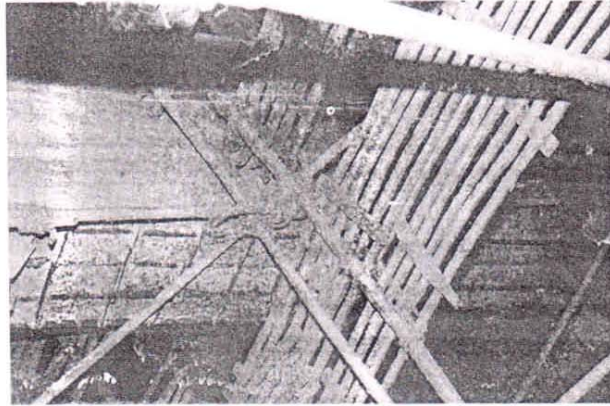
Fig 3 Corrosion of reinforcements in one of the main columns (lapol grate area)

Tie beams and main column at 20-22 m level were damaged due to heat and periodical wetting and drying process, Fig 3.

After completing about 30 m² scaffolding upto 22m level, all beams were repaired with polymer-modified mortar. Main columns at 20-22 m level were badly damaged. Concrete in cover portion had completely come off. For repair of these columns the method of low-viscosity monomer injection was adopted to strengthen sub-base of parent concrete column. Subsequently, casting was done with polymer modified concrete (1:2:4) using 10 percent polymer latex. Before casting, expanded wire mesh had been fixed as an additional reinforcement, Figs 4 and 5.

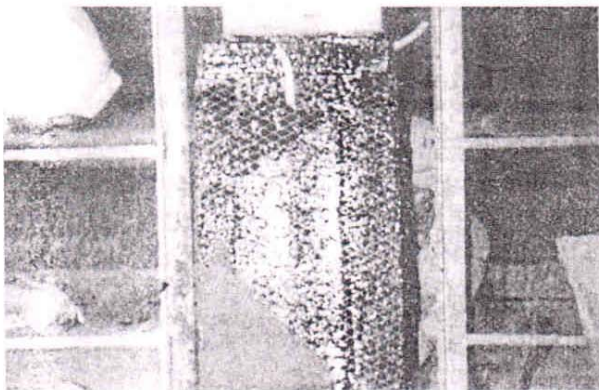
Fig 4 View of expanded wire mesh as additional reinforcement

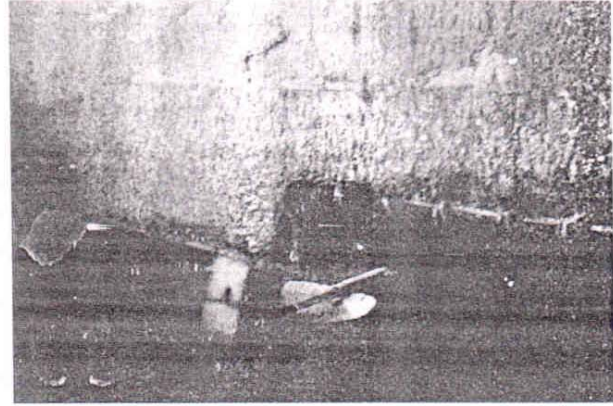
Fig 5 Application of repair mortar
